ASBESTOS INSPECTION REPORT

**FOR
LANGLEY AIR FORCE BASE
BUILDING 756
HAMPTON, VA 23665**

Prepared by:
Angela Mulleano
Asbestos Inspector #002382
Marine Chemist Service, Inc.
11850 Tug Boat Lane
Newport News, VA 23606

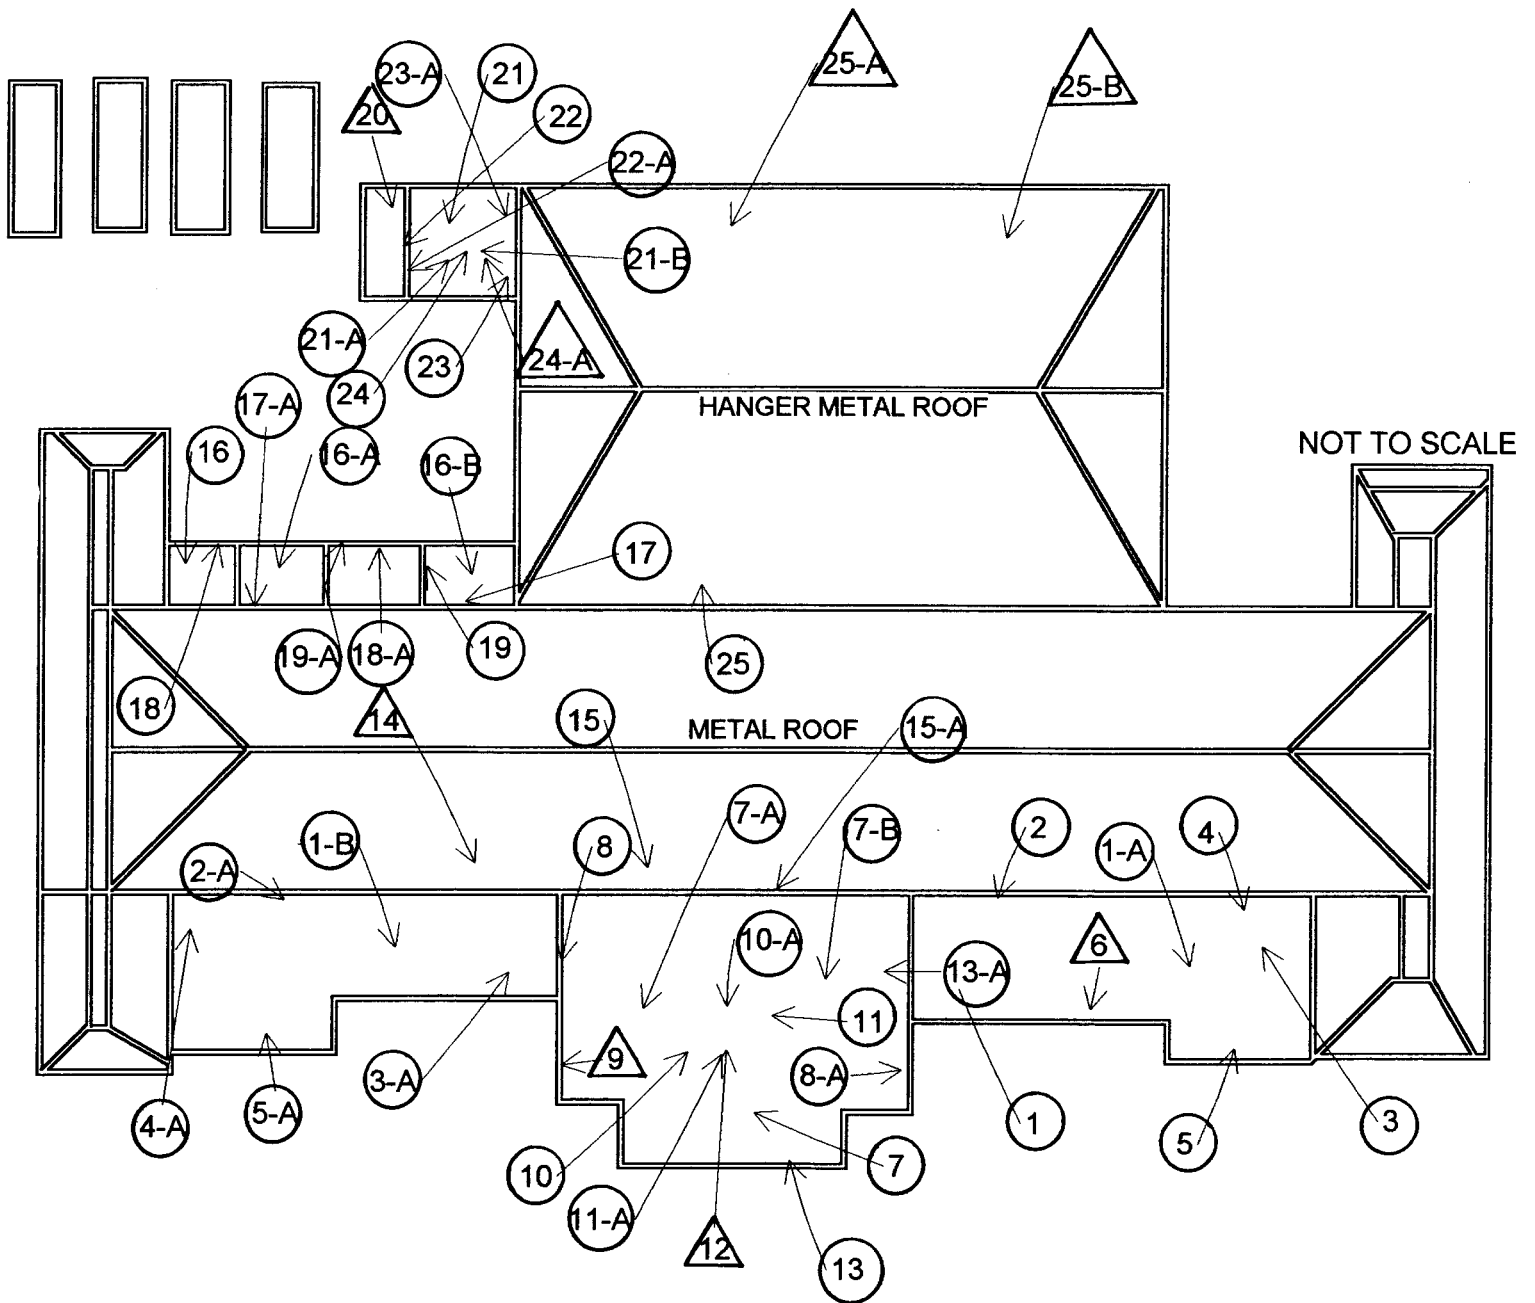
LANGLEY AIR FORCE BASE
BUILDING 756, HAMPTON, VA
ROOF PLAN

1. Sample #6 Roof cement material, 1st floor roof, contains 10% asbestos. This material is considered non- friable.
2. Sample #9 caulking material, 2nd floor roof, contains 10% asbestos. This material is considered non-friable.

3. Sample #12 black sealer material on A/C unit, 2nd floor roof, contains 15% asbestos. This material is considered non-friable.
4. Sample #14, gray roof coating on hanger roof, contains 10% asbestos. This material can be located on both side and center roof of the hanger. This roof coating material is considered non-friable.

5. Sample #20, Roof shingle, contains 10% asbestos. This material is considered non- friable.
6. Samples #25-A and #25-B, Roof coating material on small hanger, contains 10% asbestos. This material is considered non-friable.
